**POST STORM EVENT REPORT - TYPHOON PONGSONA**  
**FOR FLOOD CONTROL PROJECT**  
**Honolulu Engineer District**  
**CEPOH-EC-T**

1. Project Name: Asan River FCP
2. Date of Inspection: December 21, 2002
3. Inspection Personnel:

**Asan River**

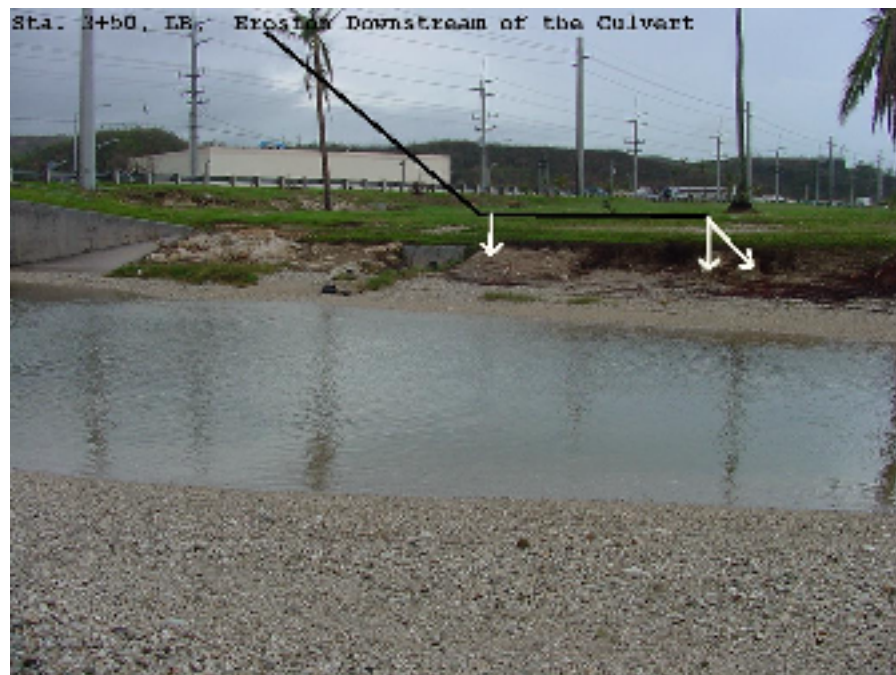
a. Sta. 4+00, Left Bank (LB), Additional erosion.

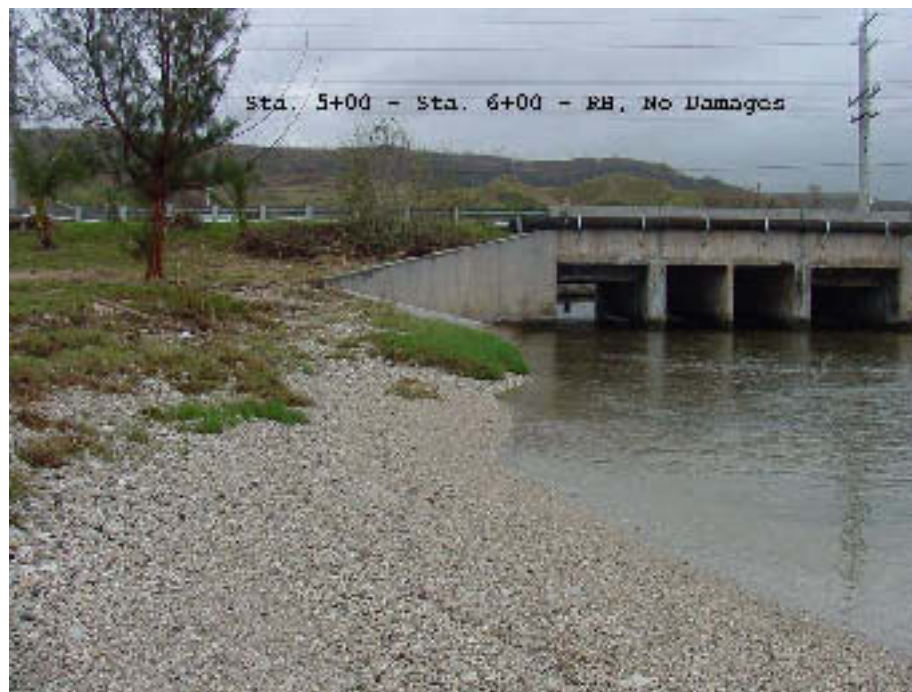
b. Sta. 6+00, Right Bank (RB), no visible damage to riprap slope protection or headwall.

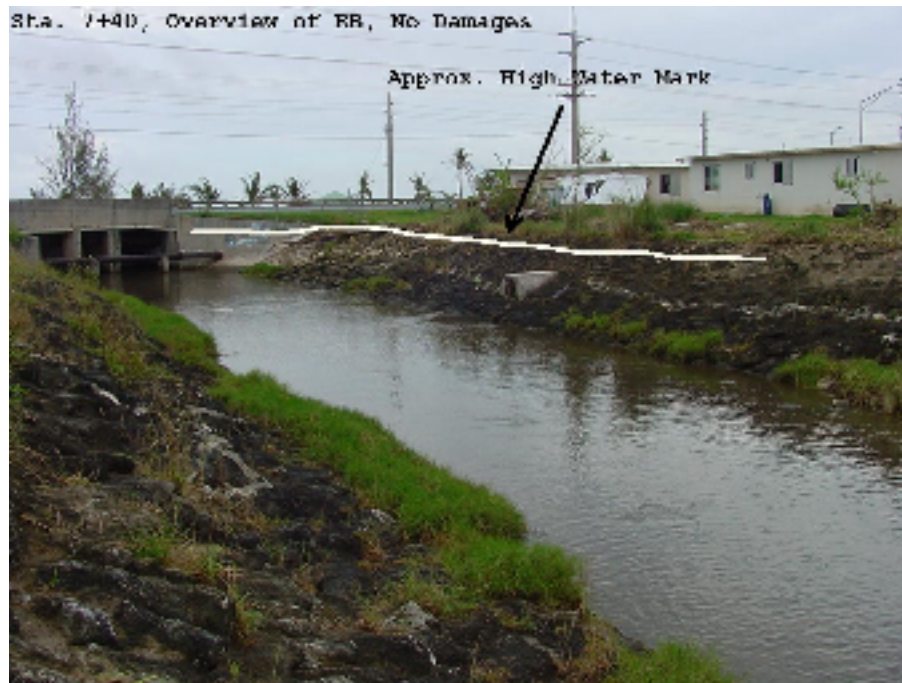
c. Sta. 7+40, Left Bank, (LB) & RB, no new damage to grouted riprap recently repaired. Note High Water Mark.

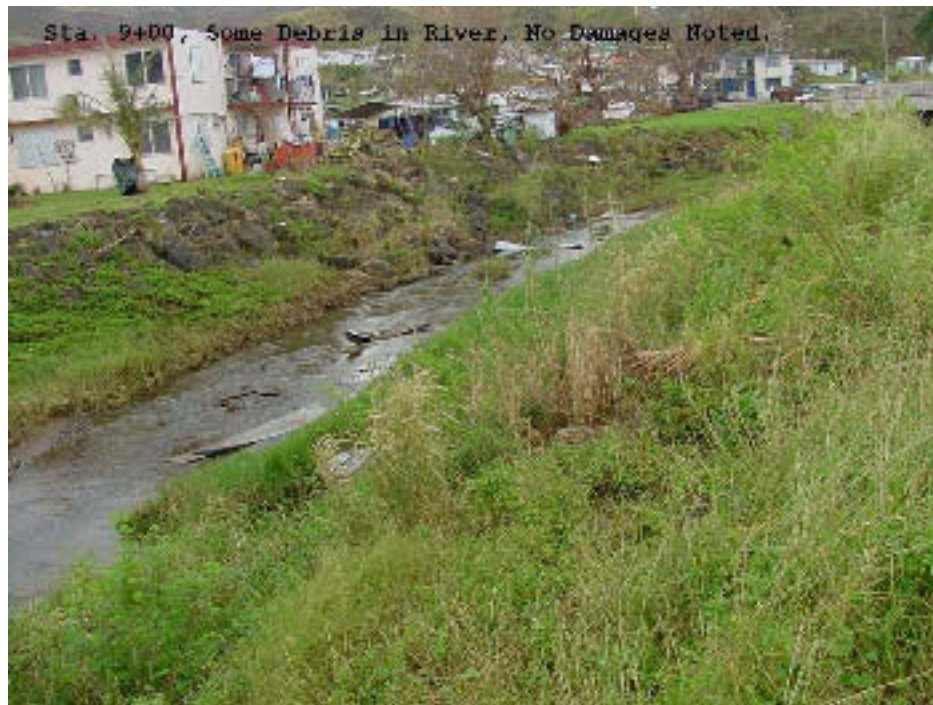
d. Sta. 9+00, Note debris in channel, unable to inspect all armor stones due to vegetation.

Some woody plants have been removed from the crest of the riprap (closer to Marine Dr.) however, heavy vegetation did prevent a more detailed inspection.

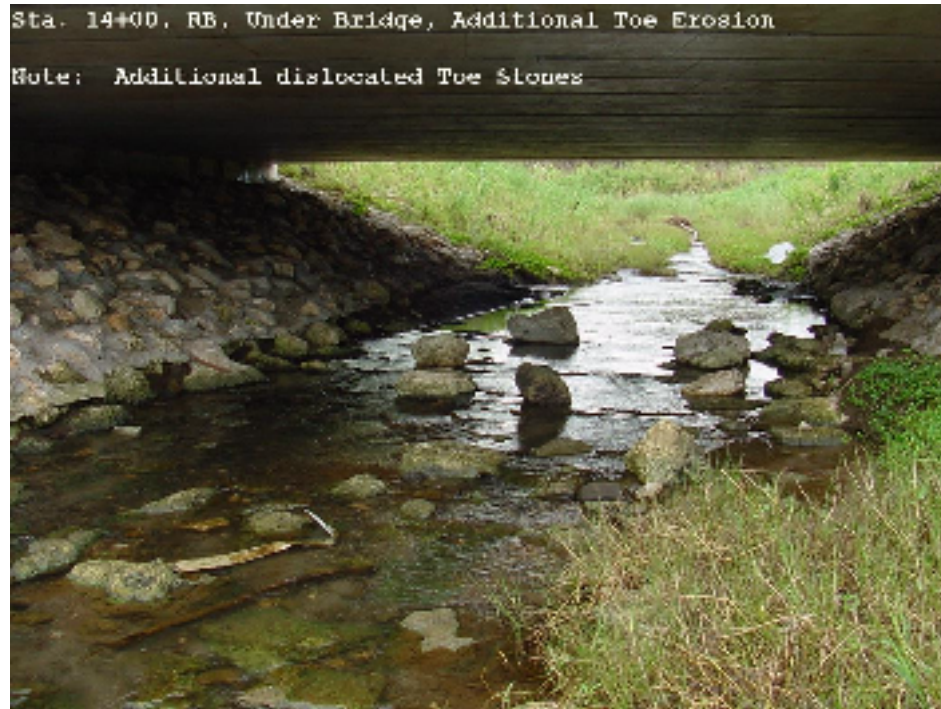
e. Sta. 14+00, Centerline, (CL), a few additional "stones" in the river, unable to determine if they are riprap stones from up-river due to vegetation.

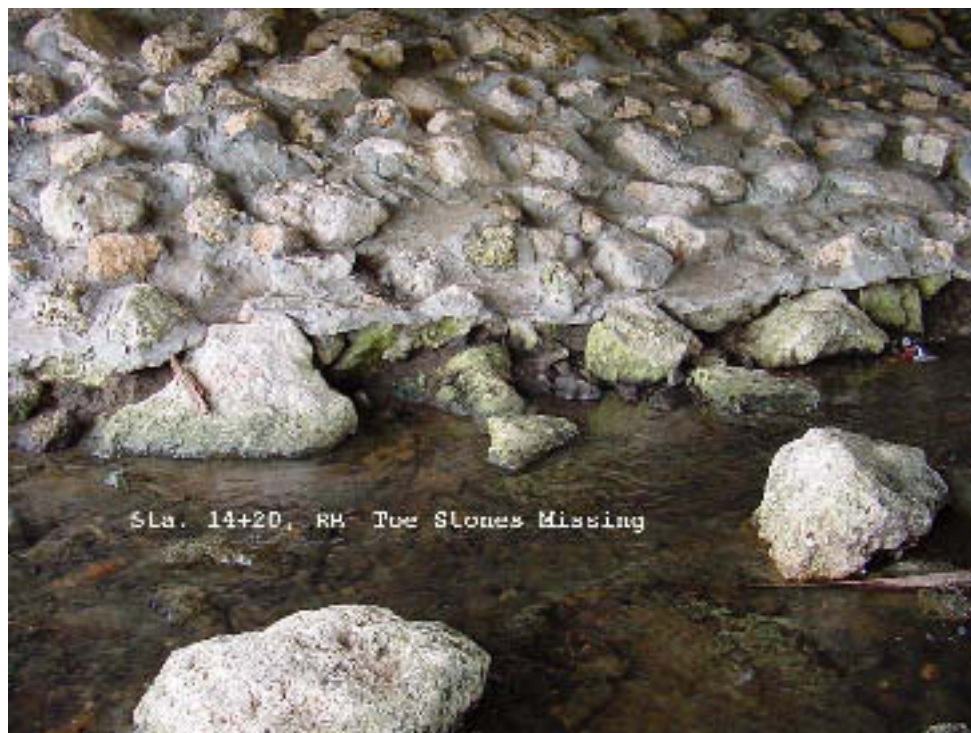
f. Sta. 14+00, RB, additional toe erosion.

Typhoon Pongsona has substantially increase the toe scouring under the upper bridge on the Asan River. This deterioration has occurred on both the left and right banks at Sta. 14+00.

Based on this inspection there were damages, which require repair.

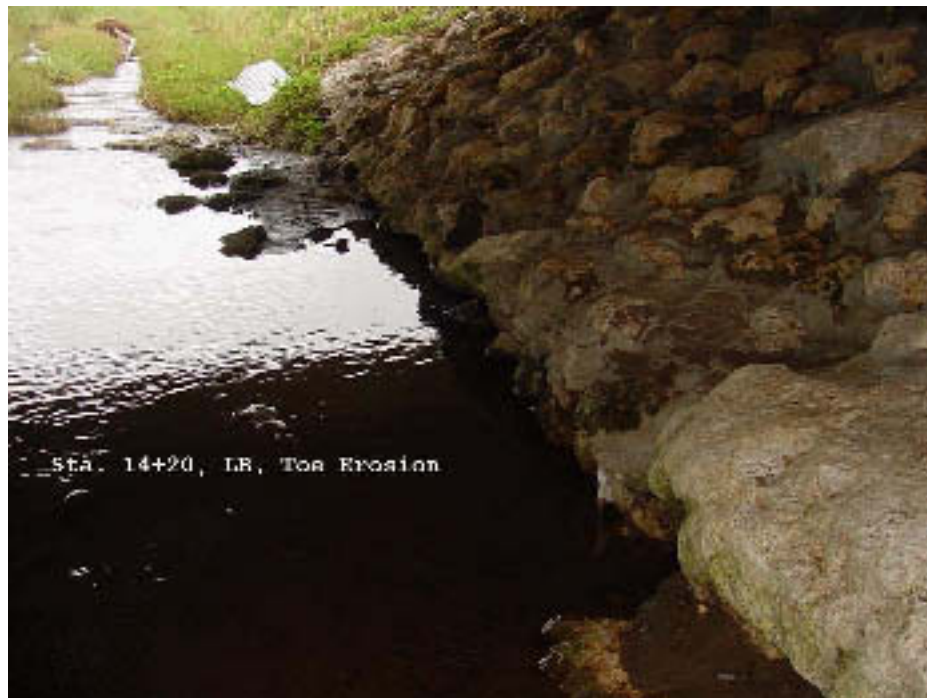
g. Sta. 14+00, LB, Toe erosion.

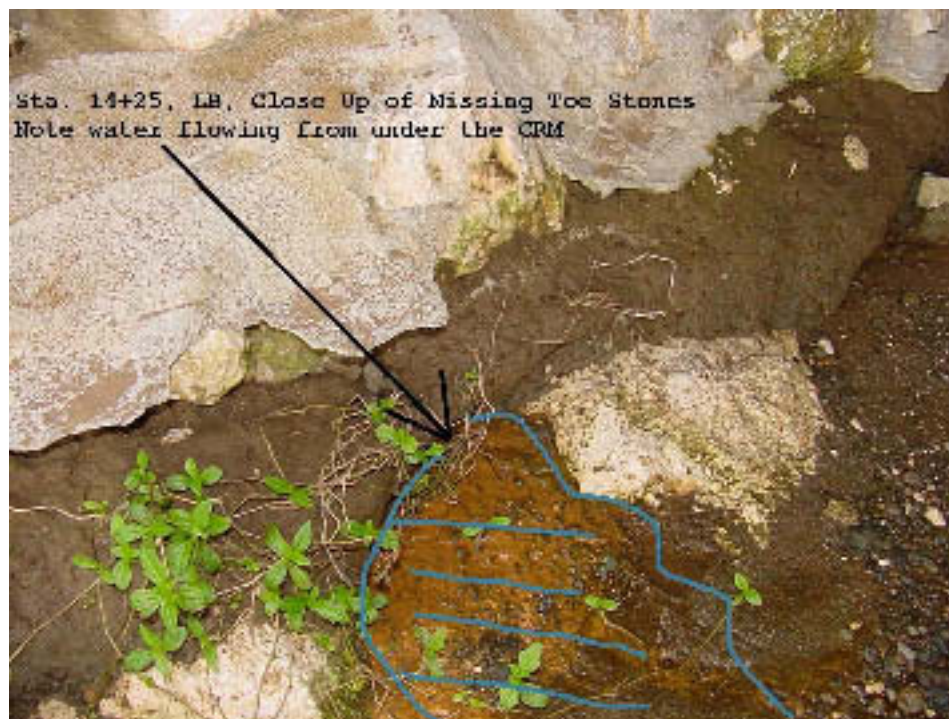
h. Sta. 14+25, LB, Close up of eroded toe area, also fresh water  
no weep holes in structure.

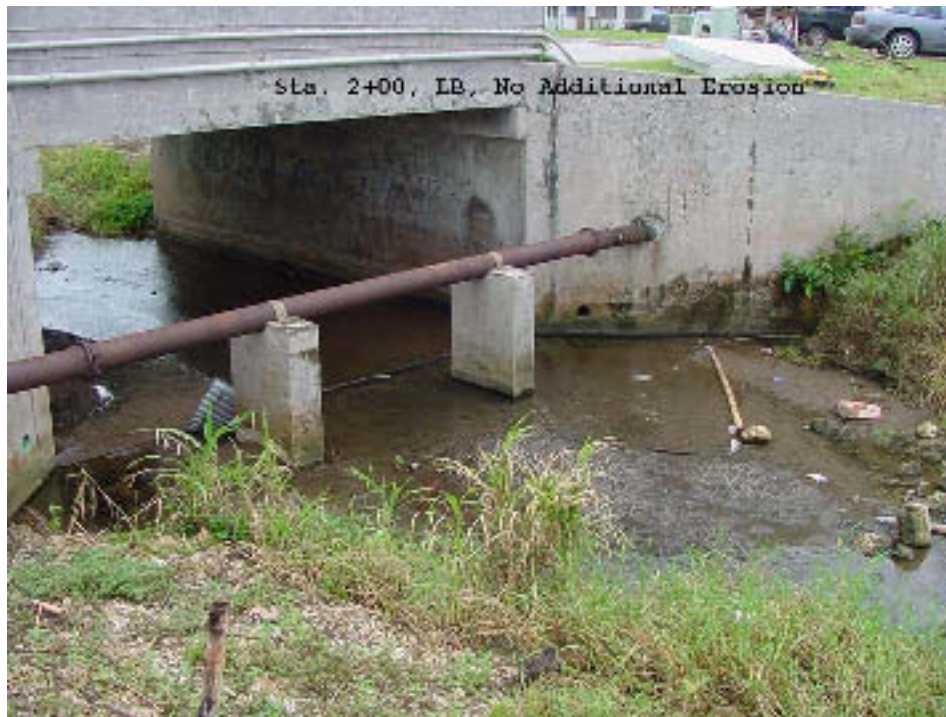
- a. Sta. 2+00, RB & LB, no additional erosions, some silt build-up.

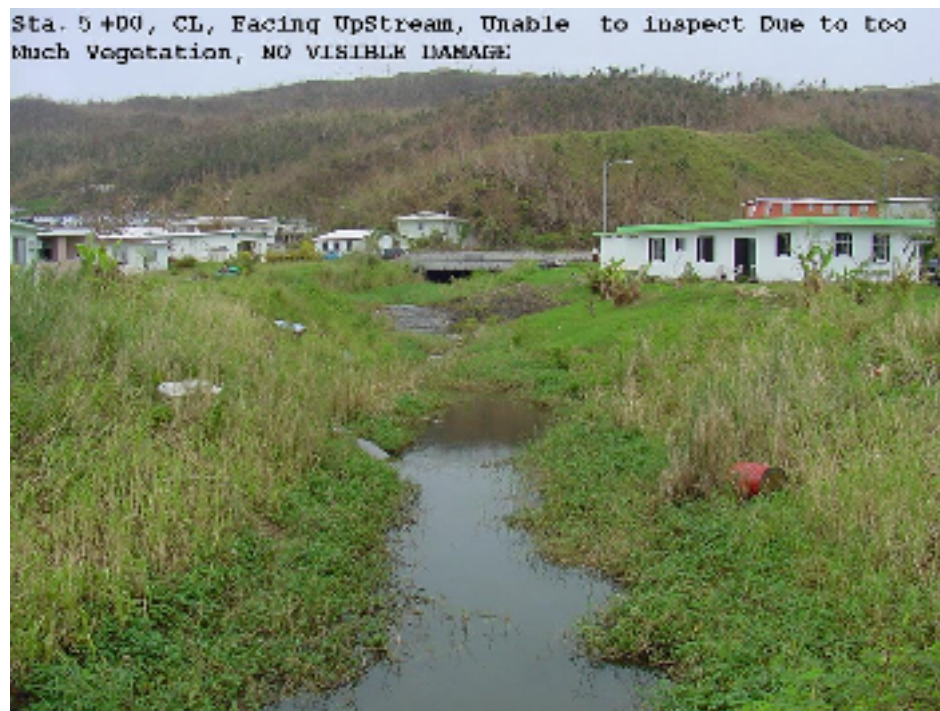
- b. Sta. 5+00, Unable to inspect due to excessive vegetation.

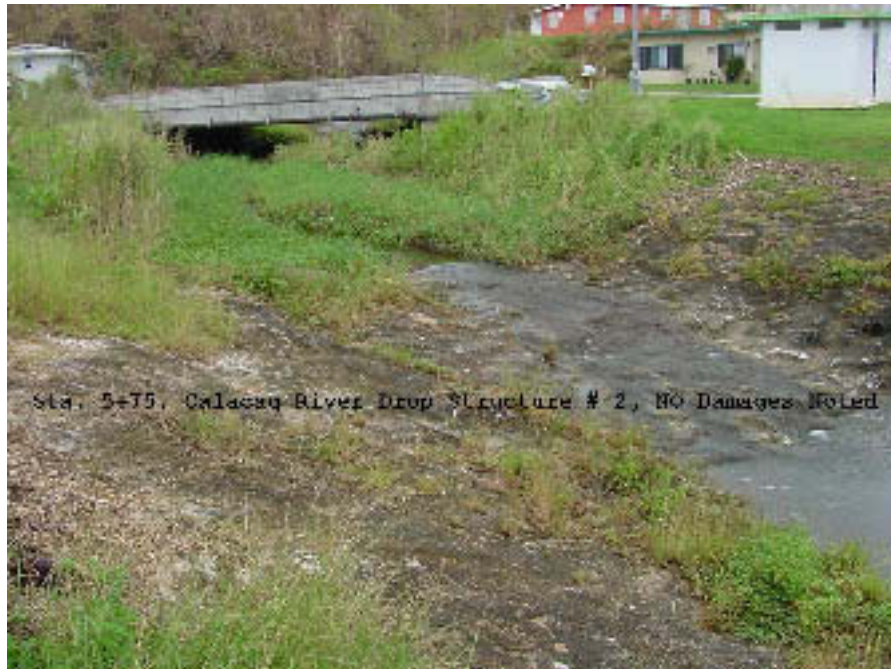
c. Sta. 5+75, # 2 Drop structure, no damages noted.

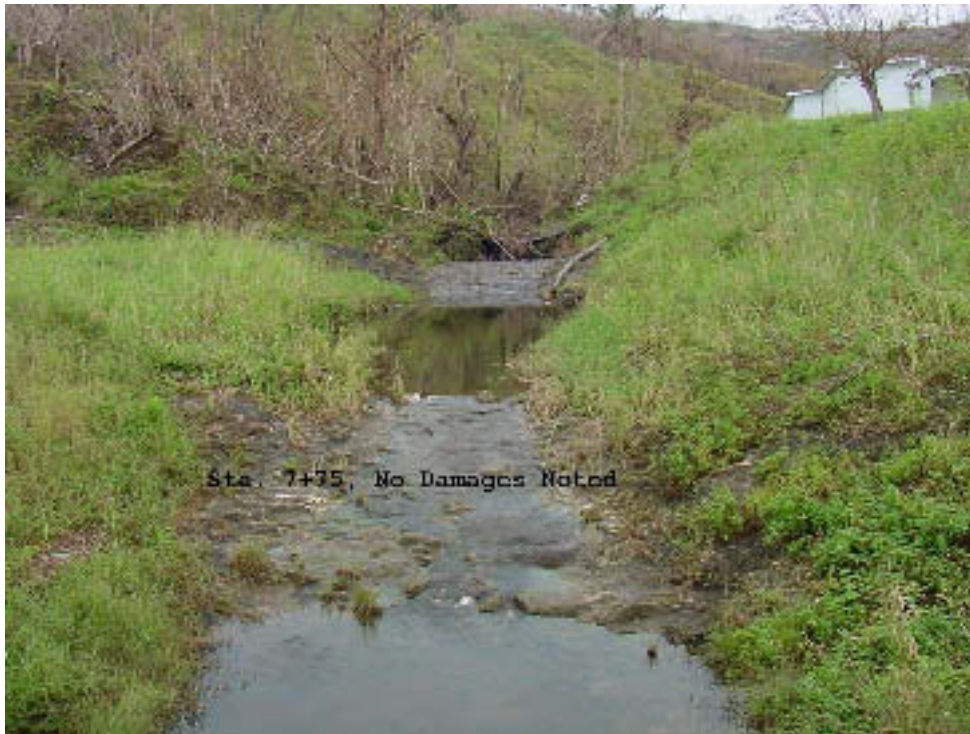
e. Sta. 7+75, CL, drop structure # 1, no damage noted.
